Troubleshooting

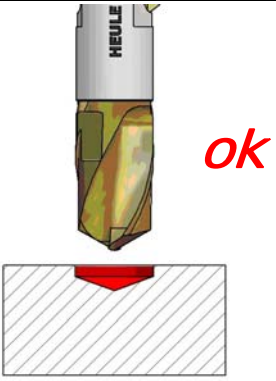
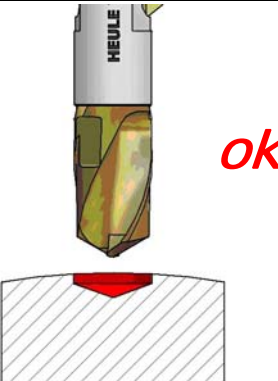
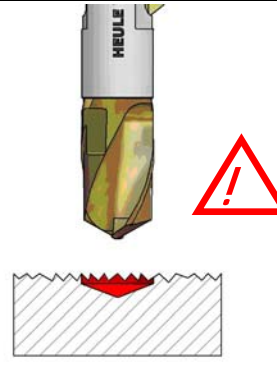
<p>Drilling of even machined surfaces.</p>	<p>Drilling on central or convex surfaces.</p>	<p>Drilling on uneven surfaces. If necessary reduce feed-rate. *</p>

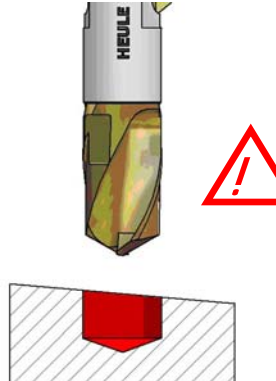
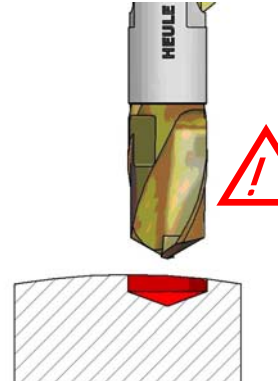
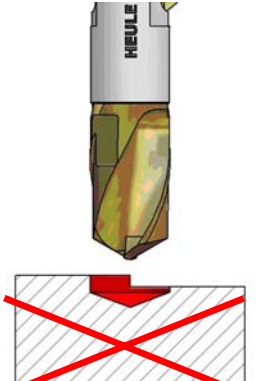
<p>Drilling on angled surfaces. *</p>	<p>Drilling on off-center convex or concave surfaces. *</p>	<p>Drilling on an uneven surface in forged or cast iron: Not possible.</p>

* Chamfer won't be clean

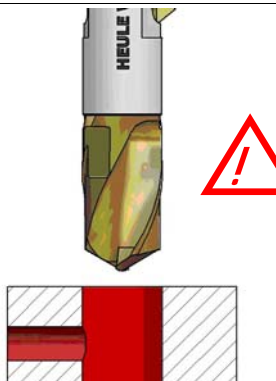
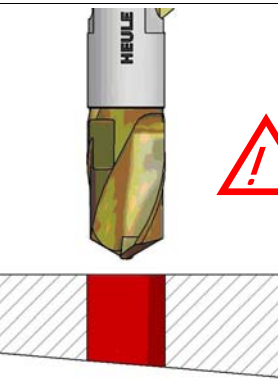
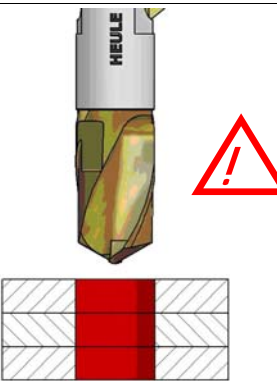
<p>Drilling through a cross-hole. Ø cross-hole max. 0.5x Ø bore. If necessary reduce feed rate. **</p>	<p>Drilling with angle on back side. Reduce feed rate to about 50-60%. *</p>	<p>Drilling through several layers. Seamless fitting of the different workpieces is necessary.</p>

** Tool can break! Blade for chamfering can get stuck in the cross-hole (drive through the bore with no rotation of the tool!)
